Nuns Walk footpath runs from Kings Worthy to Abbots Barton, leading into the heart of Winchester – the eastern section (FP6) passes under and, for a short distance, follows the A34; the western section (FP701) runs alongside the northern edge of Winnall Moors and the banks of the River Itchen. The walk offers splendid views into the Winnall Moors nature reserve, with its abundance of wildlife.

Proposed improvement tasks are:

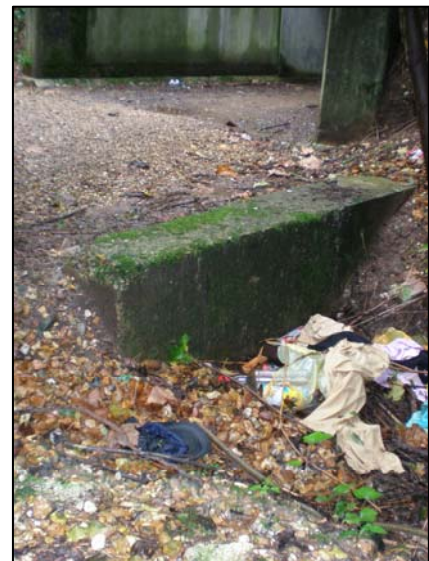
Litter in the storm drain between the A34 tunnels.

We need to clear the rubbish surrounding the underpass. There is a substantial amount, including broken glass. We may have a skip available to collect the litter in.

Some of the rubbish is lying in storm drains – care needs to be taken regarding standing water and deep mud. Some is also scattered up the steep embankments of the A34, so care will be needed retrieving this.

We could also attempt to dig out the storm drain between the tunnels, which has become silted up.

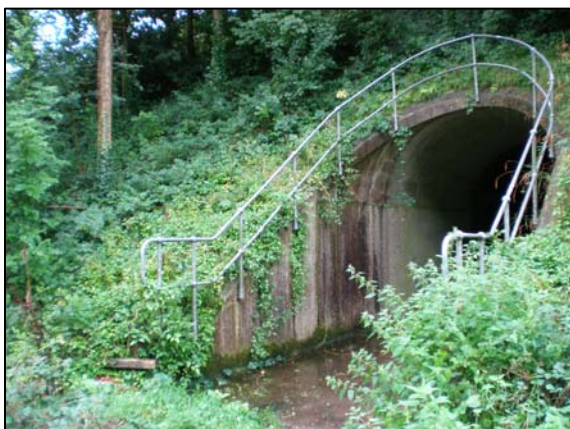
Undergrowth surrounding the tunnels causes water to run onto the concrete floor.

We need to scrape the mud and water out of the tunnels using spades. In order to reduce the water running into the tunnels, we could dig a slight trench around the concrete lip of the tunnel entrance. This would be difficult because of the height and steepness of the ground. (Long-term options would be to put a raised walkway along one side of the tunnels, or to create French drains across the fronts of the tunnels.)

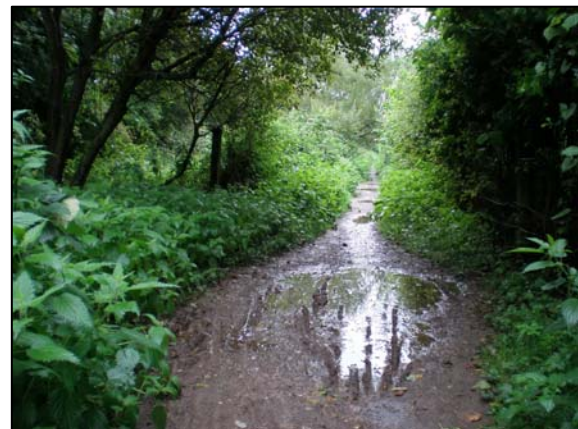
Deep potholes need filling, and a new layer of hard surfacing needs to be spread along the path.

We will need to transport aggregate through the tunnels to the stretch of path parallel to the A34, where we will fill some deep potholes and put a new layer of hard surfacing down above the muddiest stretches. We will have a mechanical barrow and compactor for this task. In order to get access, we may first need to cut down and remove stinging nettles, possibly using scythes and rakes.

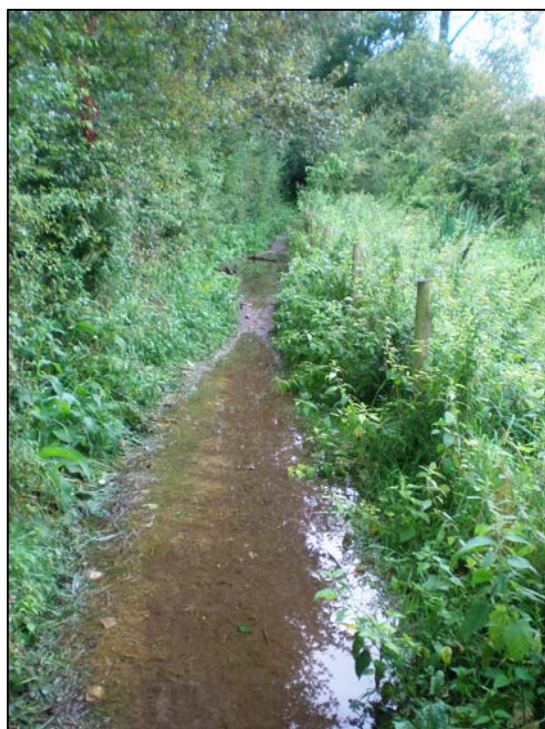
At present, stretches of the path are under up to two inches of water following a lot of rain. This needs to be addressed as the path is impassable to anyone without waterproof boots. Possible options include some or all of the following:

This shows the lengthy stretch of path that is currently flooded ...

- Cutting drainage channels leading from the path to the river (difficult due to wire fence),
- Embedding new sleeper bridges (as are already in place elsewhere on the same stretch of path);
- Using aggregate to raise the level of the path (making appropriate allowance for drainage, to avoid shifting the problem further along the path);
- Using a long plank of wood and a few bricks to make a temporary bridge (easy, but probably not very safe).

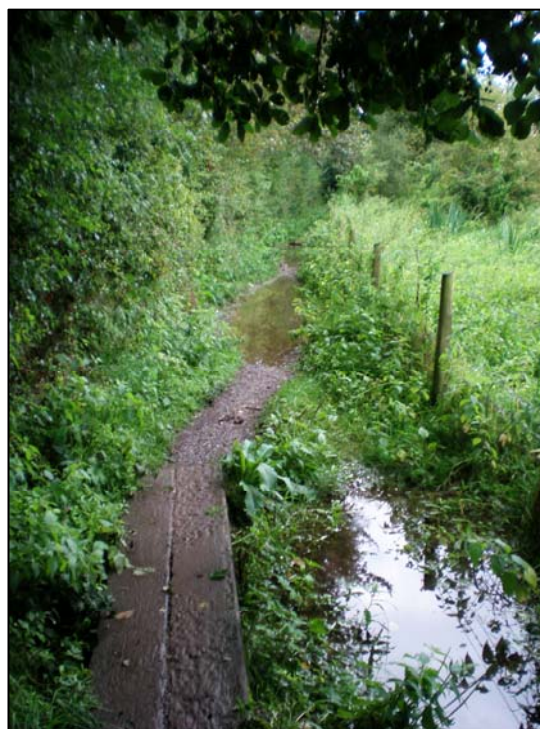
... and this shows one of the existing sleeper bridges. A series of bridges with a raised path in between may be the best option.
